Manhole Inspection Summary

Manhole # S37II_014MH

Insp Date: **3/16/07 9:59 AM**

Location Address: **1708 BARCLAY ST**

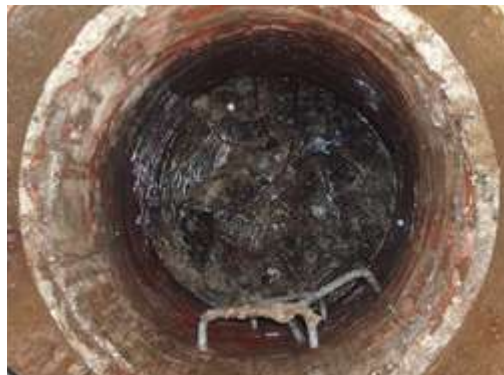
Top View

Corroded steps. Evidence of surcharge - Bench debris. Channel debris.

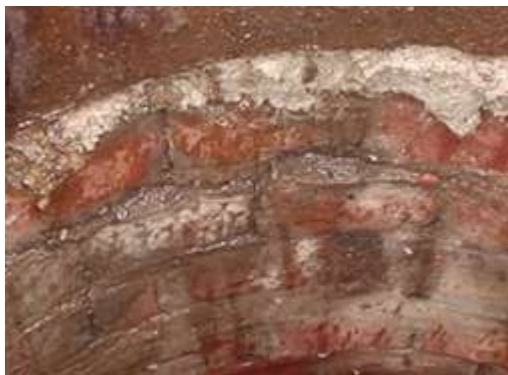
Defect

Frame leaks. Adjustment deterioration and infiltration.

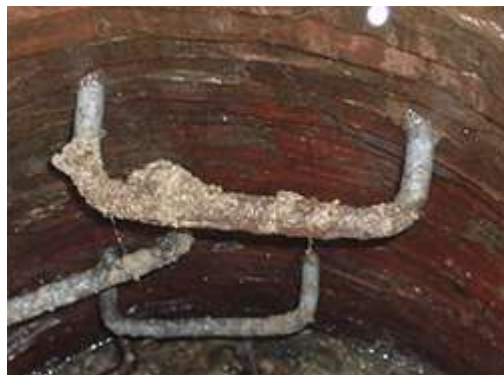
Defect

corroded step

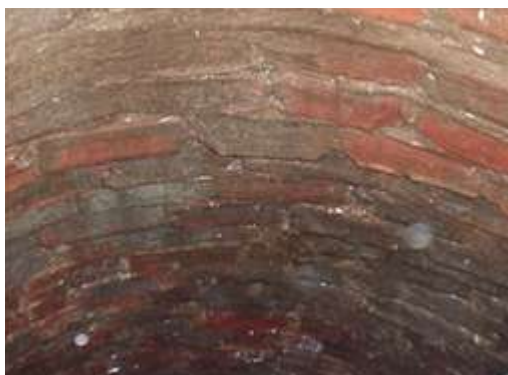
Defect

deterioration of corbel

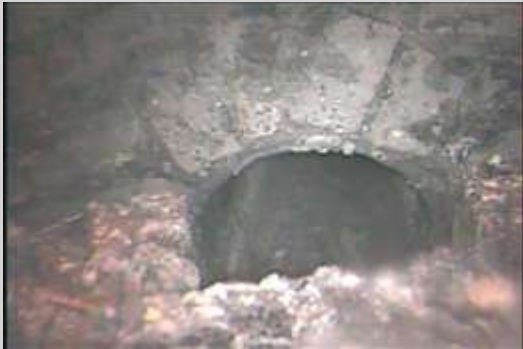
8 in. Circular Gravity Sewer Pipe Out @ 12 O'Clock

Deposits: ☐ None ☐ **Mud** ☐ Sludge ☐ **Debris** ☒ **Grease**

Silt Depth: **0** (in.) Deposits Extent: **Light**

Infiltration: **Evidence** Pipe Seal Cond: **Unknown**

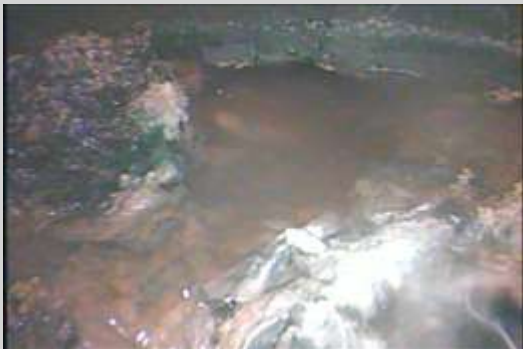
8 in. Circular Gravity Sewer Pipe In @ 9 O'Clock

Deposits: ☐ None ☒ **Mud** ☐ Sludge ☒ **Debris** ☒ **Grease**

Silt Depth: **8** (in.) Deposits Extent: **Heavy**
